Burner Test

The LINS Burner tests at Kvarntorp, 1959 - 1960

Report LINS Burner Test "Gas-KL"

Report on LINS Burner Test "Gas-XL"

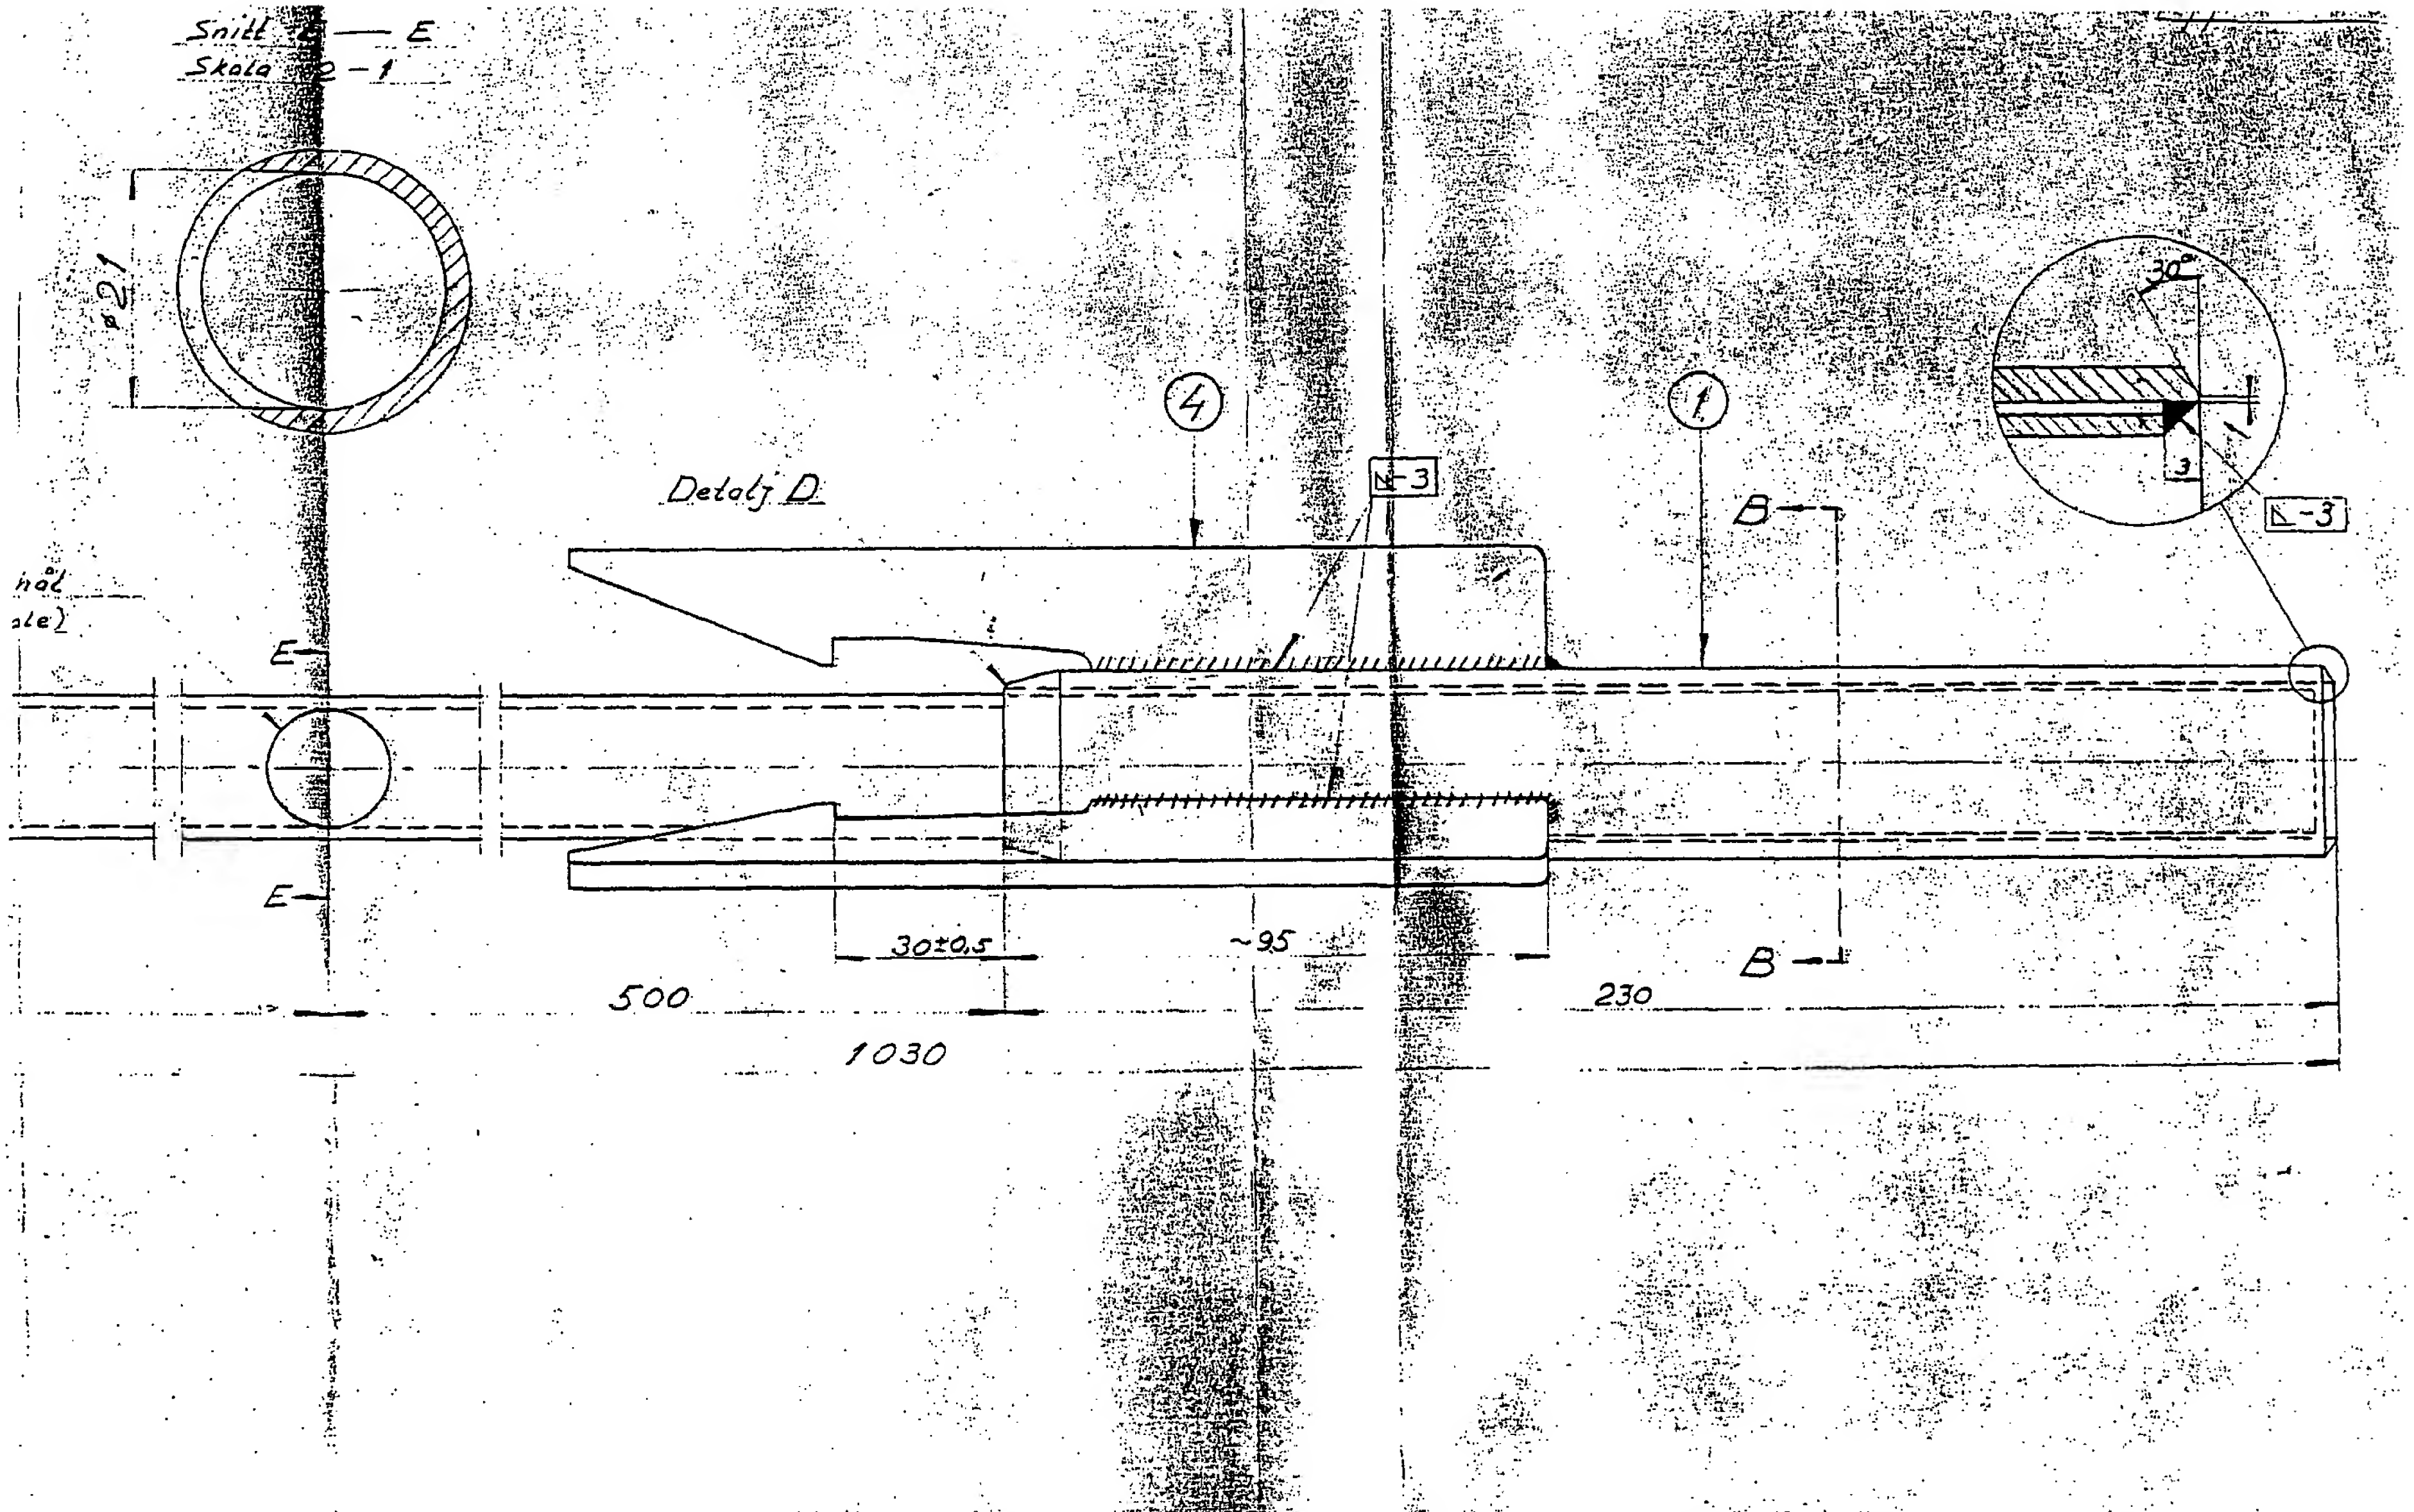
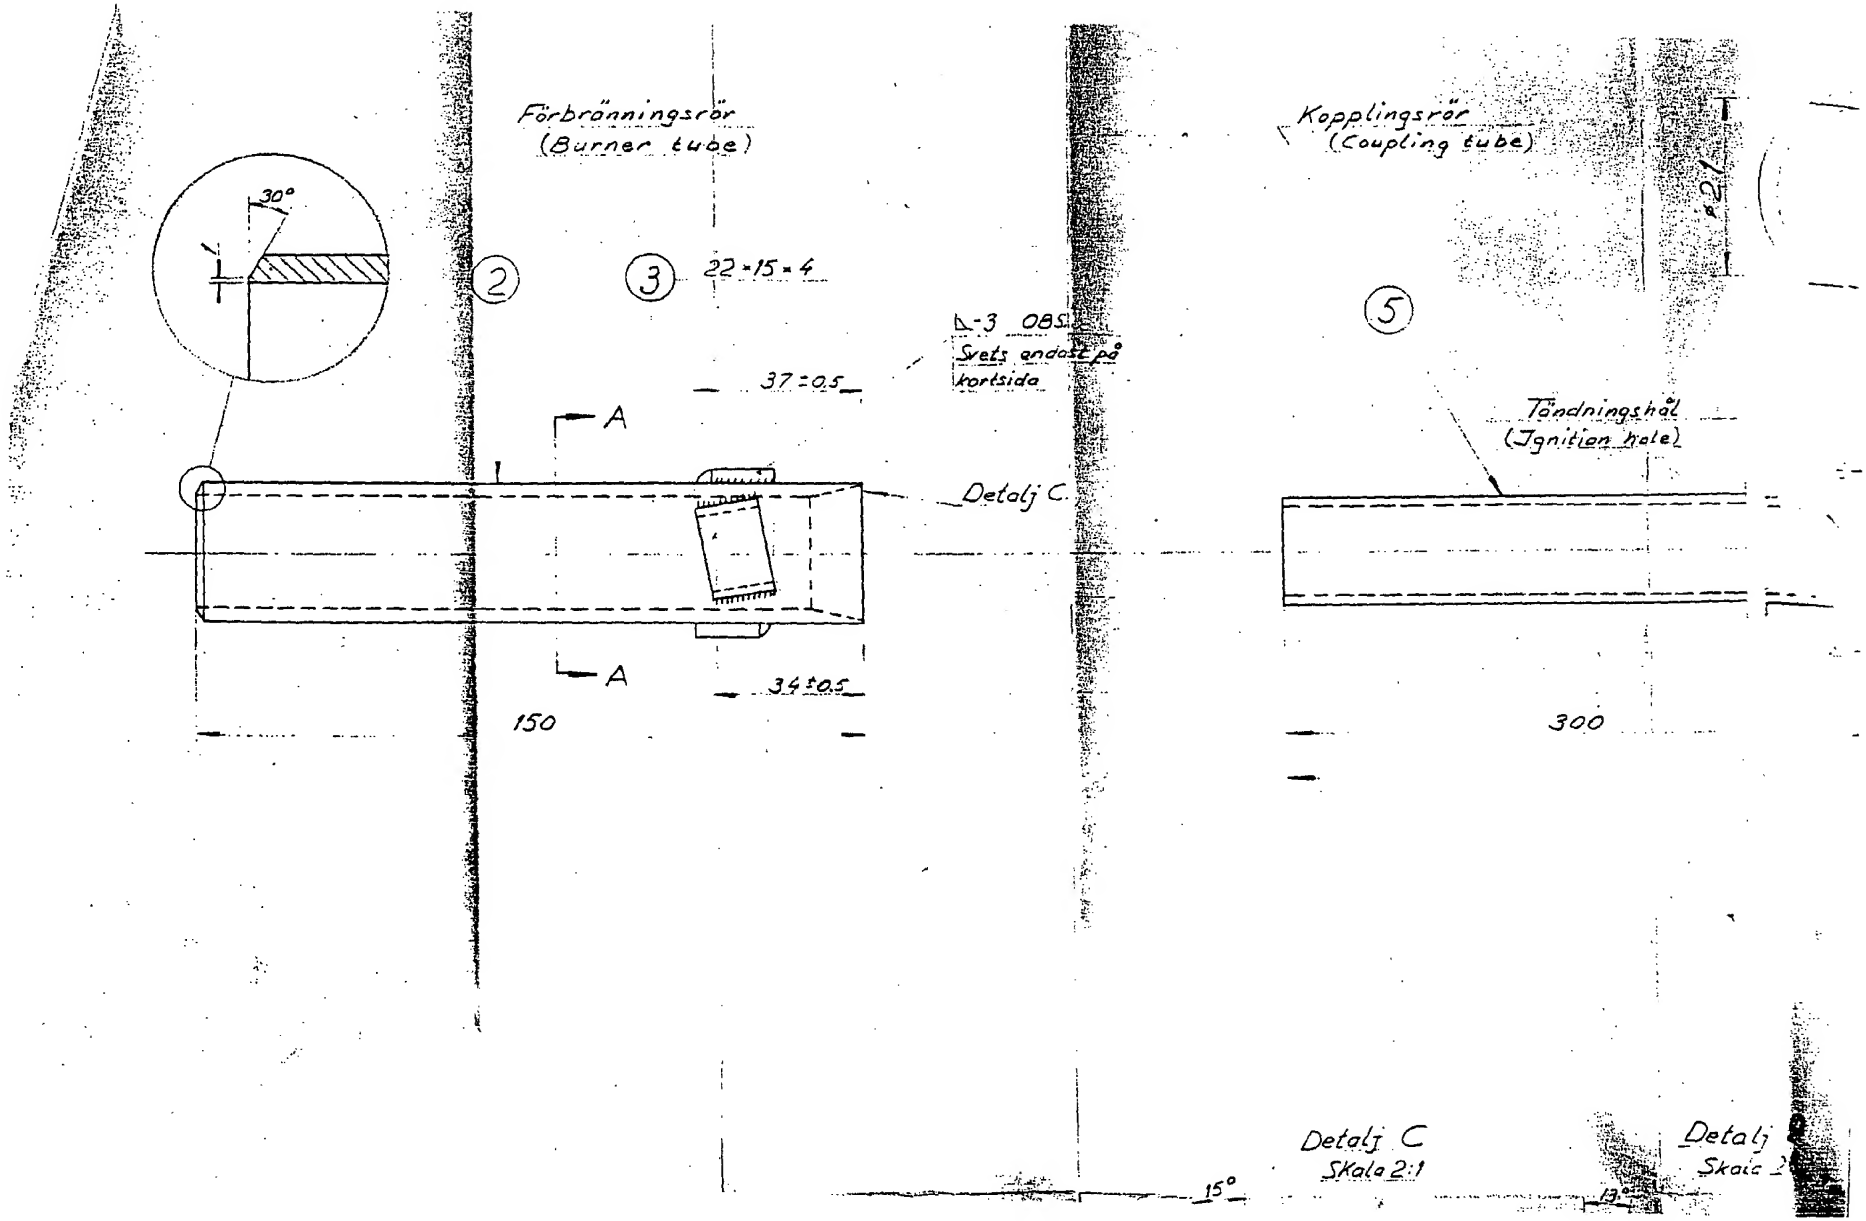
Detalj D

Förbränningsrör
(Burner tube)
30°
2
3
22-15-4
37±0.5
A
A
34±0.5
150
Detalj C
Skala 2:1
15°
Kopplingsrör
(Coupling tube)
5
Tändningshål
(Ignition hole)
300
13°

A new burner device has been developed. To facilitate the lighting of the burner without pulling it out of the sand, a burner tube coupling has been designed. This functions so that part of the burner tube, which is above the sand can be separated from the remaining burner tube part and then pulled a couple of inches. After the burner has been lit, the burner parts can easily be sealed together by the burner tube coupling.

Before the burners were started again, efforts were made to find a method to light the burner without pulling it out of the sand. It was found that this can be done by cutting off the burner tube horizontally above the unexpanded sand level with a coupling between the parts which easily can be locked and unlocked by turning the supply tube. By this device it is enough to pull the upper burner part only a couple of inches for lighting. The burner tube coupling is shown on Fig 2. The end surfaces of the burner parts are ground conically in order to ensure a tight connection. The burner tube parts are held together by three centralizers, placed on the cone part with cutting-outs, fitting into three shoulders welded on the bottom part. Because the shoulders are placed in 10 degrees angle towards a plane perpendicular to the burner tube, the upper part can be pressed towards the bottom part by turning the supply tube above ground surface. The bottom part stands on the bottom of the burner casing with two iron "legs".

The burner tube coupling has been improved and is now tighter, but still easily separated.

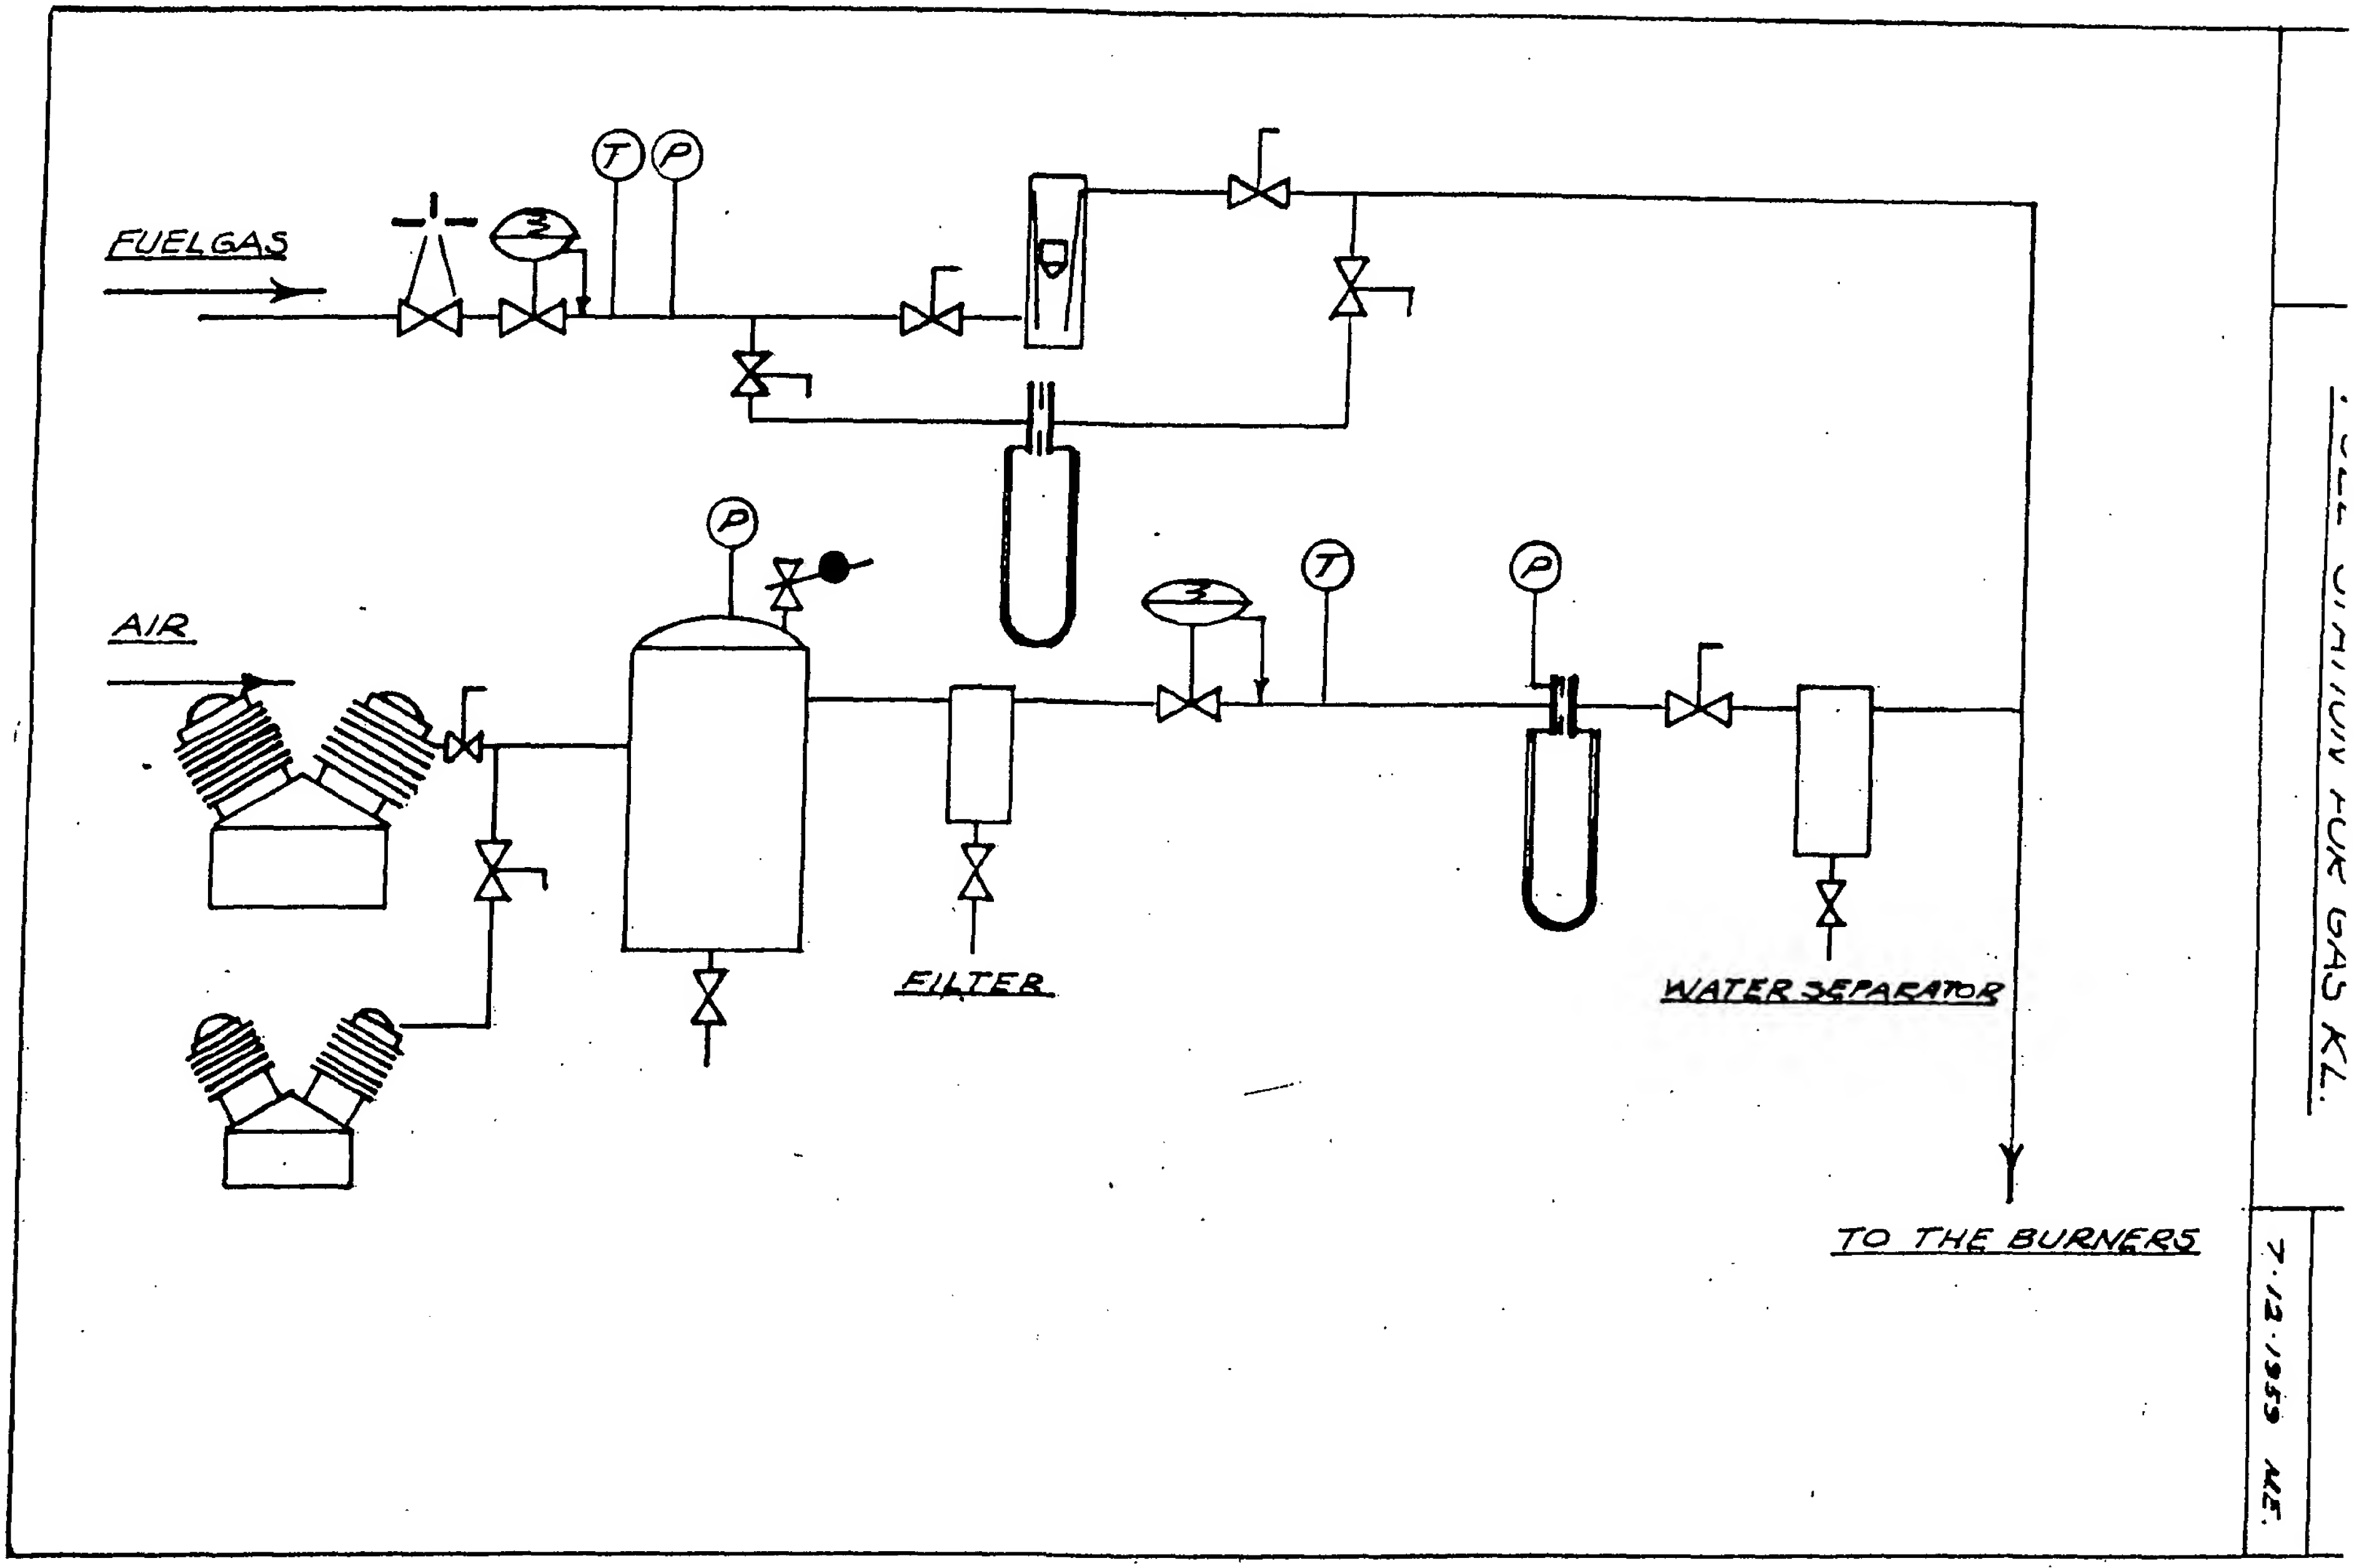
FUELGAS
AIR
FILTER
WATER SEPARATOR
TO THE BURNERS
STATION FOR GAS KL.
7·12·1959 ME.

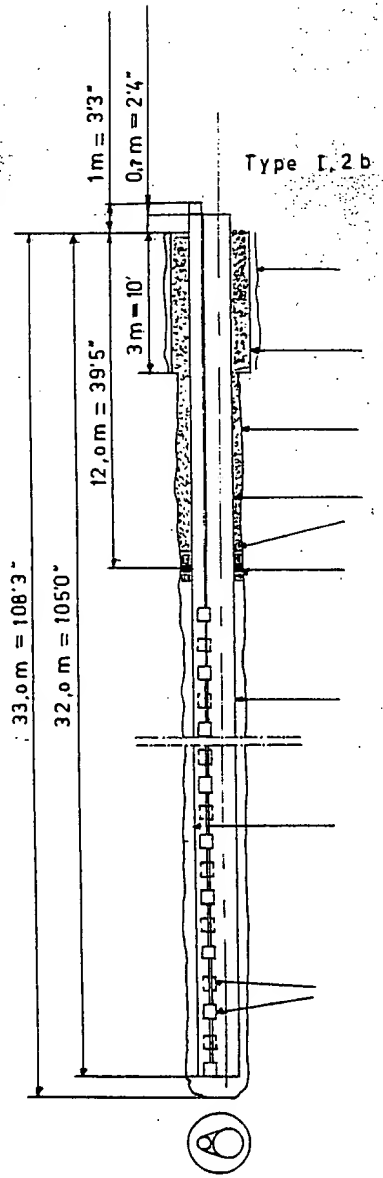
Type I, 2 b

Drillhole, ø: 147 mm = 5.80"

Soil casing,
141 x 2 mm = 5.55 x 0.08"

Type II, 2 b differs from type I, 2 b by 2 m (6'7") of 18/8 stainless steel burner casing, 89 x 3.25 mm (3.50" x 0.13"), placed at 7,7 – 9,7 m (25'3" – 31'10") in B 9 and at 6,7 – 8,7 m (22'0" – 28'7") in B 14 from bottom of casing.
